Rock-Ola Retrofit Installation Guide

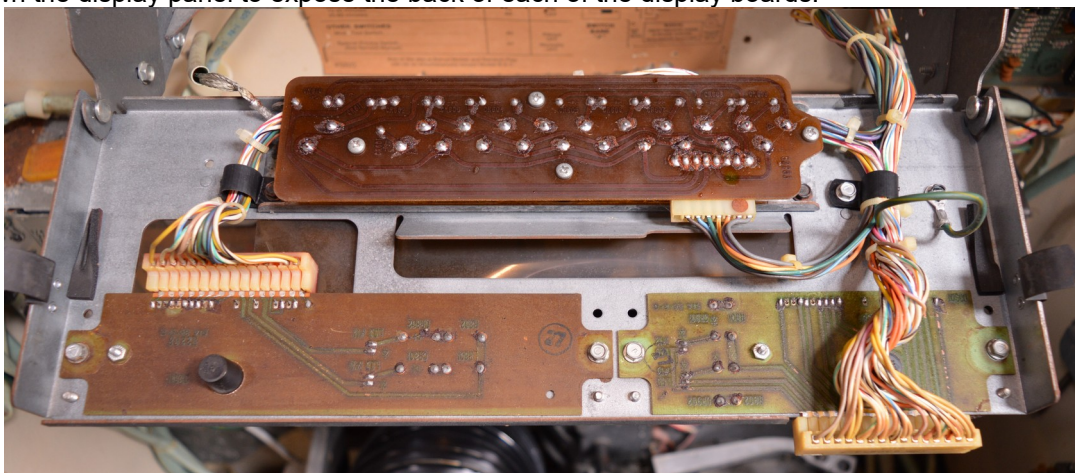
Fold-down the display panel to expose the back of each of the display boards.

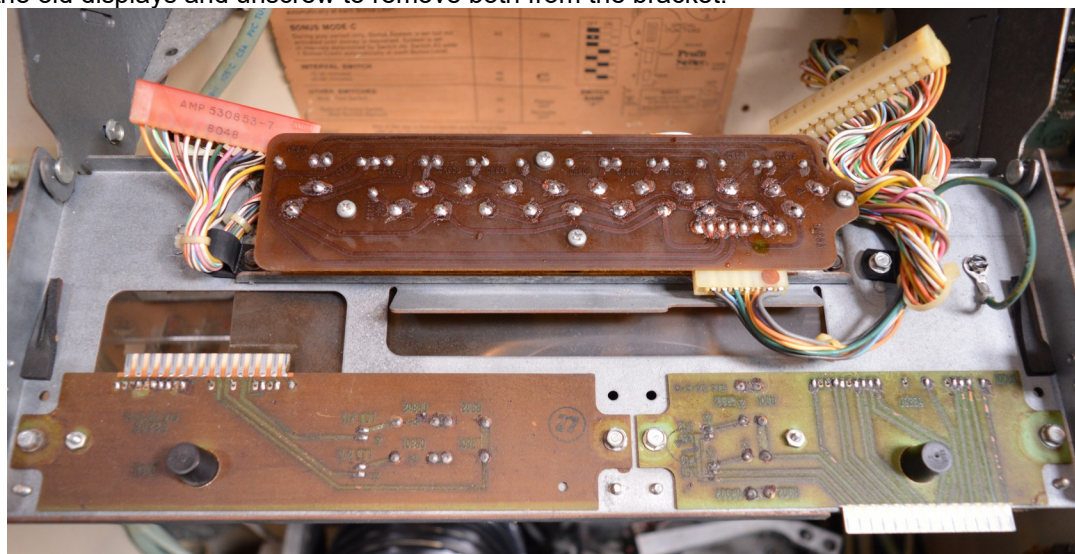
Unplug the old displays and unscrew to remove both from the bracket.

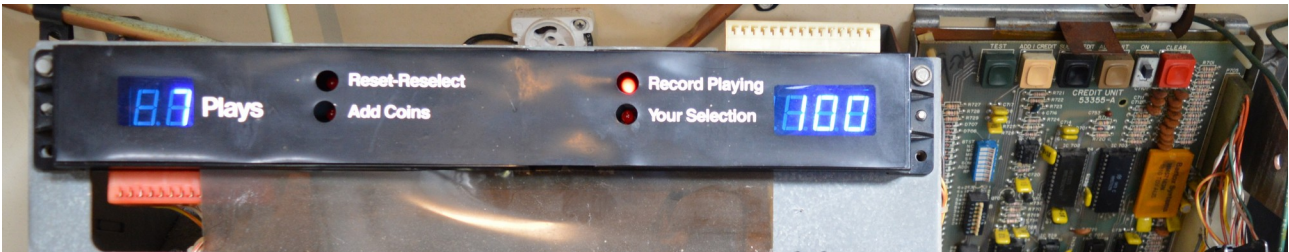
Power on the Jukebox and make a selection.

Your Jukebox should now display credits and selections.
