Rock-Ola Retrofit Installation Guide

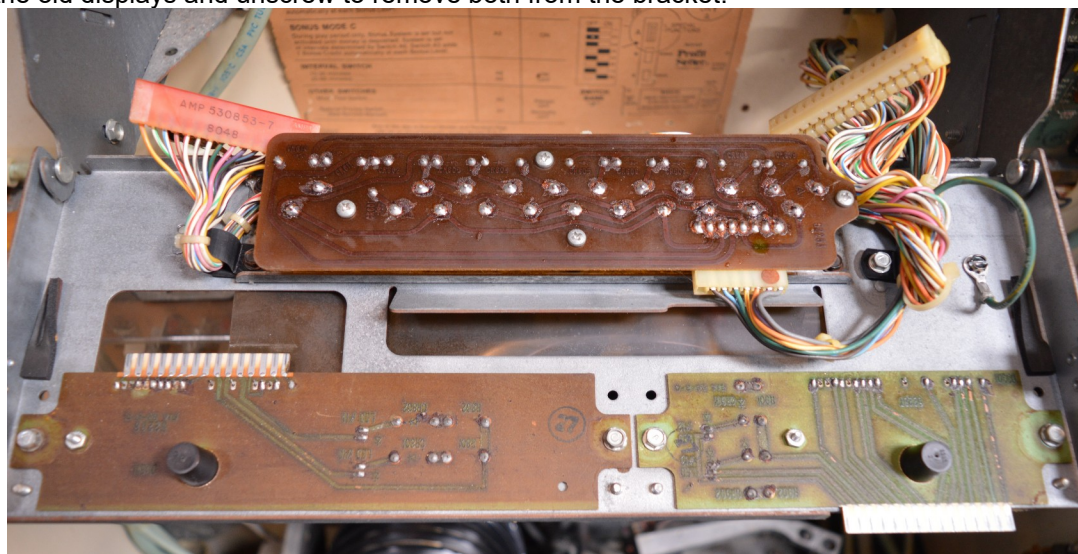
Unplug the old displays and unscrew to remove both from the bracket.

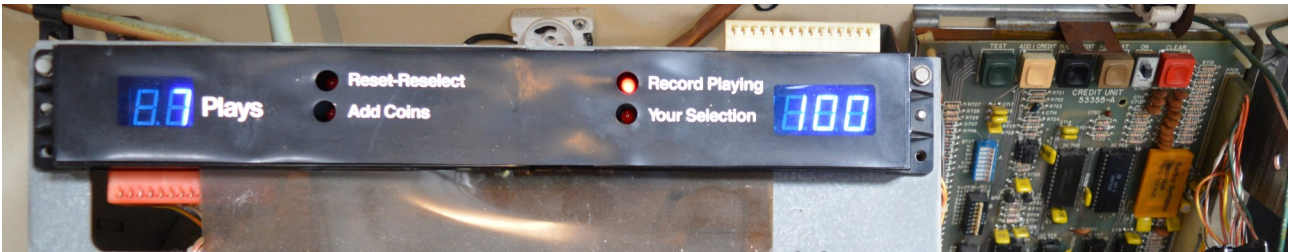
Power on the Jukebox and make a selection.

Your Jukebox should now display credits and selections.
