Rock-Ola Techna Retrofit Kit Installation Guide

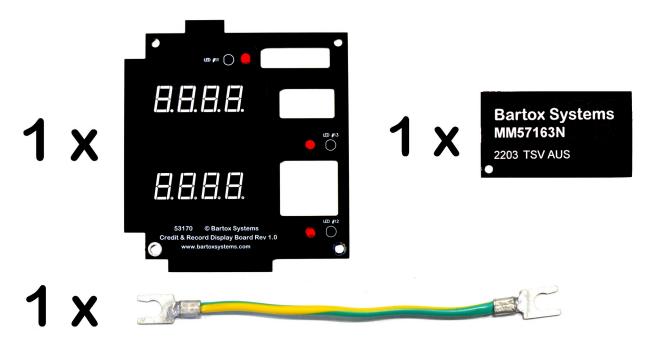
This Kit contains:

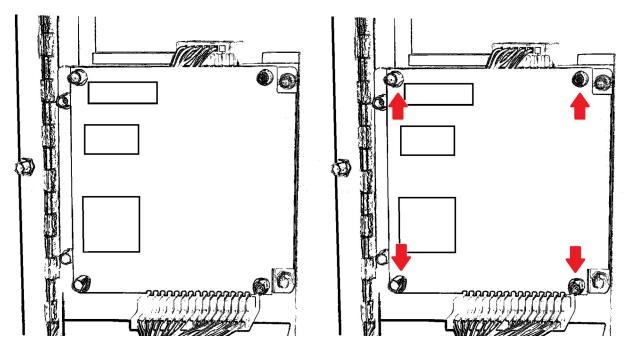
Open the display door to show the back of the Display Board.

Remove the top and bottom plugs from the old Display board

Remove only the screws indicated by the arrows.

Remove the old display board.

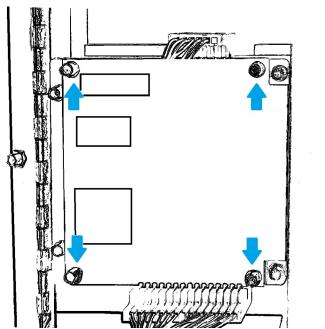
Reconnect the top and bottom display connectors

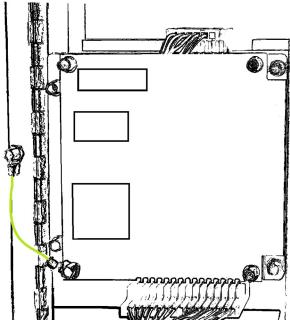
Attach the earth cable to the display door hinge and the earth point on the display board as shown. (this is required for the display to function)

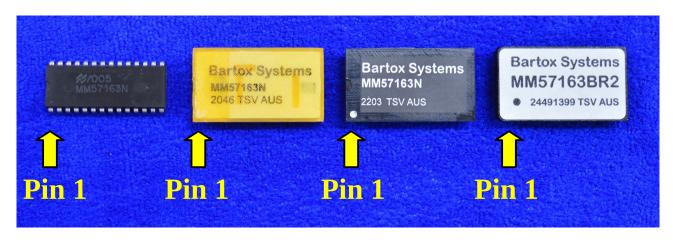
Please note the location of Pin 1.

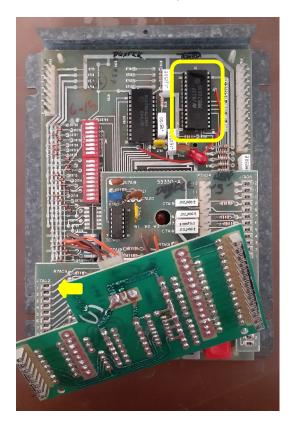
Profit Setter 52455

Take the Credit unit out of the Jukebox and remove the top cover.

Remove the old MM57163N and install the new one.

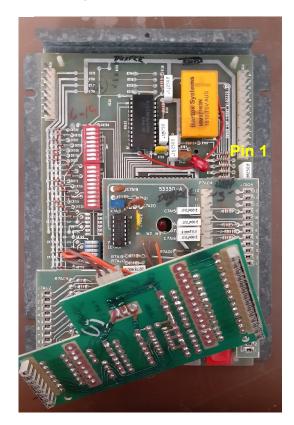
Remove the top rider to expose the board underneath.

Note the orientation and location of Pin 1

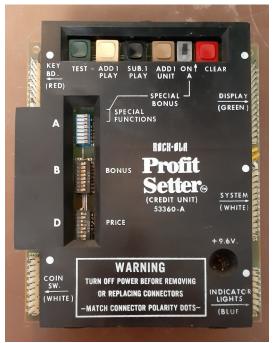
Profit Setter 53360

Take the Credit Unit out of the Jukebox and remove the top cover.

Note the orientation and location of Pin 1.

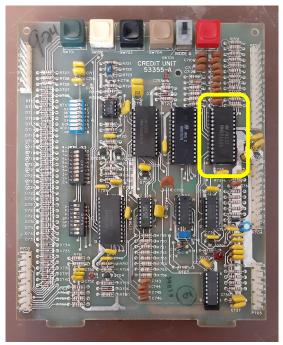
Remove the old MM57163N and install the new one.
